Manhole Inspection Summary

Manhole # S17C1_010MH

Location Address: **1905 deering av** Cross Street: **washington bd**

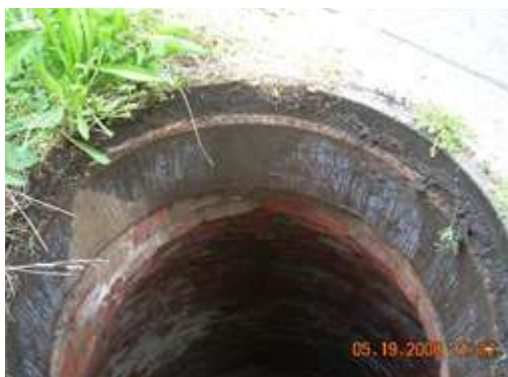
Defect 1

Frame Offset: **0** (in.) Condition: ☐ Sound ☐ Cracked ☒ **Leaks**

frame leaks-inflow evidence from sheeting

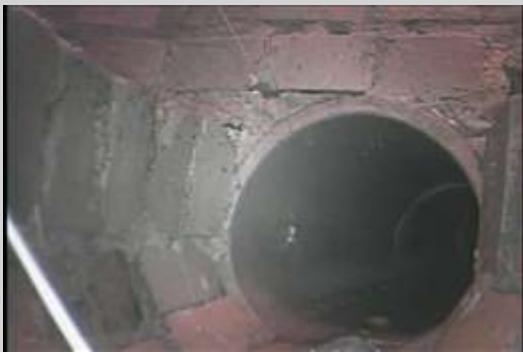
12 O'Clock Outflow

8 in. Circular Gravity Sewer
Pipe Out @ 12 O'Clock

Pipe Height: **8.4** (in.) Rod and Bar (Angled)
Pipe Material: **Clay** ☐ Pipe Lined
Invert Depth: **7.83** (ft.) Flow Characteristics: **Slow**
Deposits: ☒ None ☐ Mud ☐ Sludge ☐ Debris ☐ Grease
Silt Depth: **0** (in.) Deposits Extent:
Infiltration: **None** Pipe Seal Cond: **Sound**

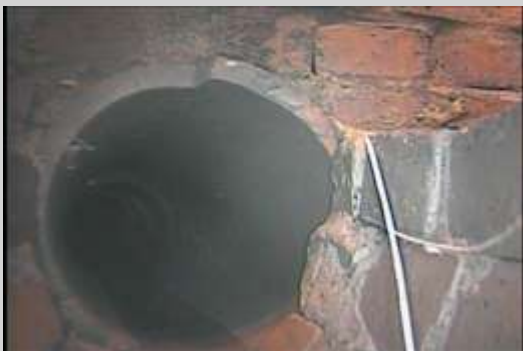
3 O'Clock Inflow

8 in. Circular Gravity Sewer
Pipe In @ 3 O'Clock

Pipe Height: **8.4** (in.) Rod and Bar (Angled)
Pipe Material: **Clay** ☐ Pipe Lined
Invert Depth: **7.54** (ft.) Flow Characteristics: **Slow**
Deposits: ☒ None ☐ Mud ☐ Sludge ☐ Debris ☐ Grease
Silt Depth: **0** (in.) Deposits Extent:
Infiltration: **None** Pipe Seal Cond: **Sound**
